TEST AND ON-ORBIT EXPERIENCES OF FALCONSAT-3

William W. Saylor, PE⁽¹⁾, Col Martin E. B. France⁽¹⁾

ABSTRACT

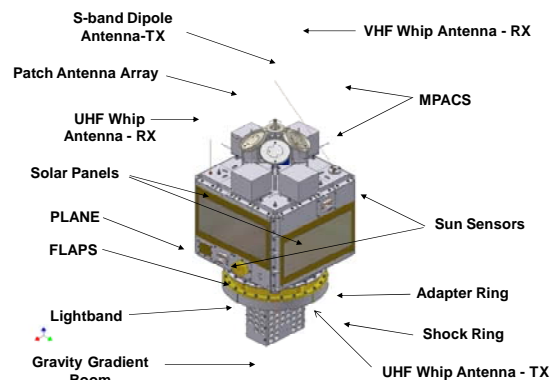
Figure 1. FalconSAT-3 External View

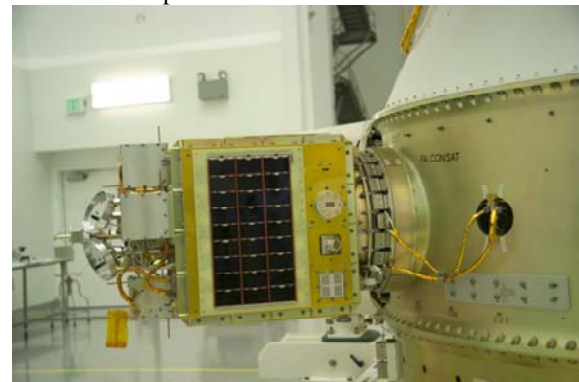
Figure 5. FalconSAT-3 mounted on ESPA Ring

The mounting ring separation system required for this mission was a 15 in (38.1 cm), 24-bolt motorized (or non-motorized for FalconSAT-3) lightband from Planetary Systems Corporation (PSC). This system eliminates the pyroshock from a pyrotechnic initiated separation system and provides a controlled, spring force-driven separation from the launch vehicle.

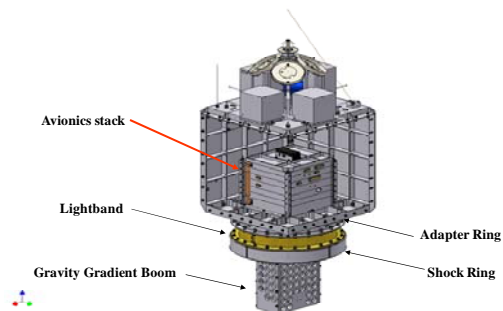
Figure 7. FalconSAT-3 Internal View

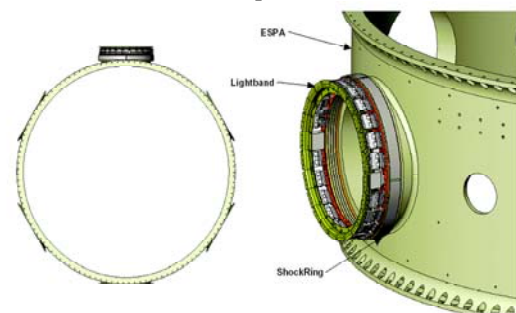
Figure 8. Shock Ring and Lightband

One other object of the SEM and QM environmental testing was to determine what performance of the shock ring was required. The use of a lightband as a separation system meant that the satellite fundamental frequency would appear to be lowered since the compressed

lightband does have some lower frequency modes than the relatively stiff aluminium box that comprises the satellite body. The instrumented results of the SEM indicated that the response function of the shock ring needed to be modified. Analysis of the test data allowed the vendor to re-design a different response function into the shock ring and the result of that effort was a successful QM test.

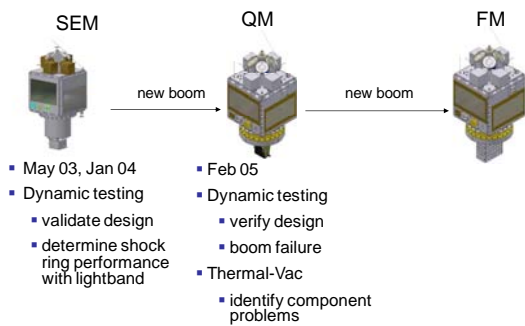
Figure 9. FalconSAT-3 test Sequence

Typically the testing approach includes four separate stages. The first stage is the construction of a physical model. The physical model can be constructed of cardboard or plywood and serves as a means to visualize what the spacecraft will look like and how payloads, avionics, and wire harness can be accommodated. This is where the initial trade-off studies and design decisions are made.

The second major item is a structural engineering model (SEM). The SEM is a duplicate of the satellite structure that will be flown and the avionics and payload components are simulated using mass dummies. The mass and volume of the SEM are the same as the flight model and are subjected to a vibration and shock environment that determines whether or not the structural design is adequate to handle the launch loads. The SEM test is also instrumented well enough to identify variations in the defined launch load environment that can be seen at various places in the structure.

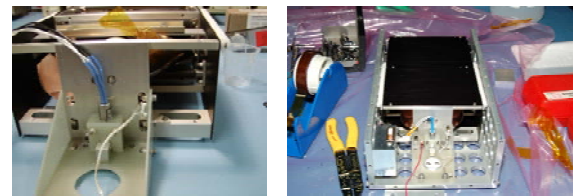
- > NGST boom has new pyrotechnic release device
- > New firing circuit designed, built, and tested at USAFA
- > Inadvertent boom deployment and pyrotechnic safety issues resolved in Mission System Program Safety Plan (MSPSP) process

Figure 12. New Pyrotechnic Firing Circuit Added

The new vendor was required to demonstrate successful deployment and the satellite team was required to develop and test a new firing circuit. This was the one exception to the general testing philosophy where the components were qualification and acceptance tested as components and bolted onto the satellite after final acceptance testing of the FM.

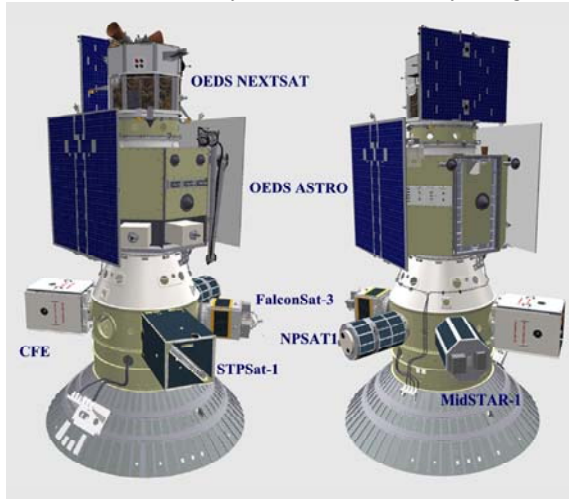
Figure 13. STP-1 Mission Configuration

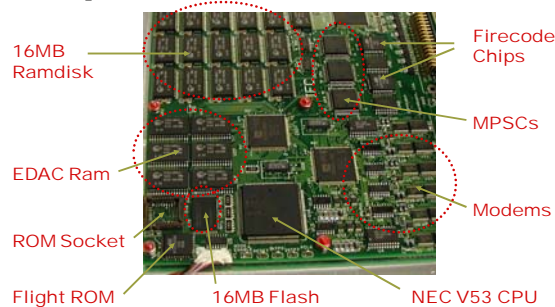
Figure 15. FalconSAT-3 IFC

The operations crew also made several attempts to reset the IFC using a "firecode" signal that sends a simulated watchdog timer reset to the CPU. Unfortunately this is not a true watchdog timer reset since there is no power

cycling of the processor. This signal resets the vectors on the CPU in the IFC and clears the states to a supposedly known state.

After a firecode reset signal to the satellite the bootloader starts its initialization and flight code loading sequence. If that process can be interrupted within 30 seconds of a reset then the IFC executes just the simple bootloader commands. Since USAFA did not have access to the source code of the bootloader the vendor was enlisted to attempt communication with the satellite. The vendor was able to reset and then freeze the bootloader process so that it became possible to communicate with what is essentially the BIOS on the satellite processor.

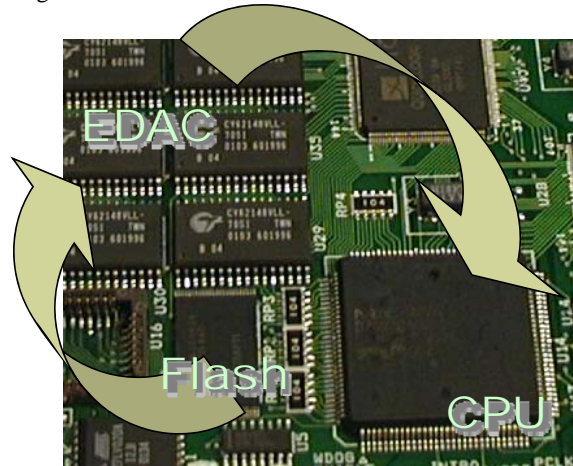
Figure 16. FalconSAT-3 Boot Sequence

1. Power to the IFC causes it to execute the bootloader code in the processor PROM
2. The PROM containing the bootloader code is socketed and has been tested extensively on both the QM and FM versions of the satellite
3. The bootloader writes the base flight code from FLASH (EPROM) memory into the error detection and correction (EDAC) memory.
4. The flight code then starts executing and waits for the first command received from the USAFA ground station to turn on the transmitter and start broadcasting telemetry.

When communication with the bootloader program was established it did provide limited telemetry that determined the battery voltage and temperature were normal and that there were no obvious hardware failures. The next question was to determine why the satellite could not successfully load and execute the flight code.

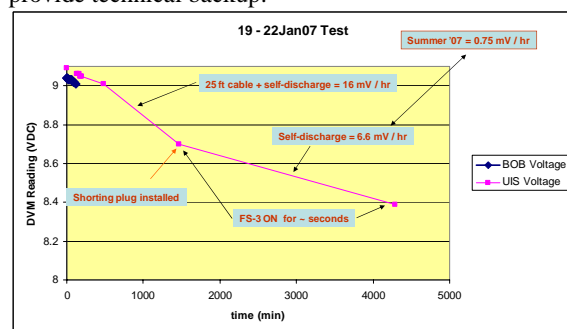
Figure 18. Battery Test Results

The battery system on FalconSAT-3 consists of seven NiCad 'D' cells rated at 4 A-hr each. These batteries have a significant flight heritage and have proven to be remarkably robust. The flight cells used in the satellite were only three years old at the time of launch and had plenty of shelf life left. Testing with the batteries indicated that there was a self discharge rate less than 0.75 mV/hr. However when the batteries were checked just prior to encapsulation 6 weeks later, the battery voltage had dropped to less than 1.0 V on a nominal 9.8 V power bus. The battery voltage should have been approximately 8.1 V and this complete discharge of the batteries to approximately 0.1 V per cell was the source of significant concern. Initial attempts to re-charge the batteries through the umbilical cable were only partially successful until the charging procedures were changed to reflect the increased resistance of the 500 foot cable. The batteries were very carefully charged (while monitoring temperature) and the apparent discharge rate was measured for several days. For reasons that are still not clear (leakage in the cable?, spacecraft internal faults?). The batteries now demonstrated a 10x increase in discharge rate to 6.6 mV/hr.
